The Case for a Change in the Color of Titanic's Cargo Hatch Coamings

By Bob Read, D.M.D.

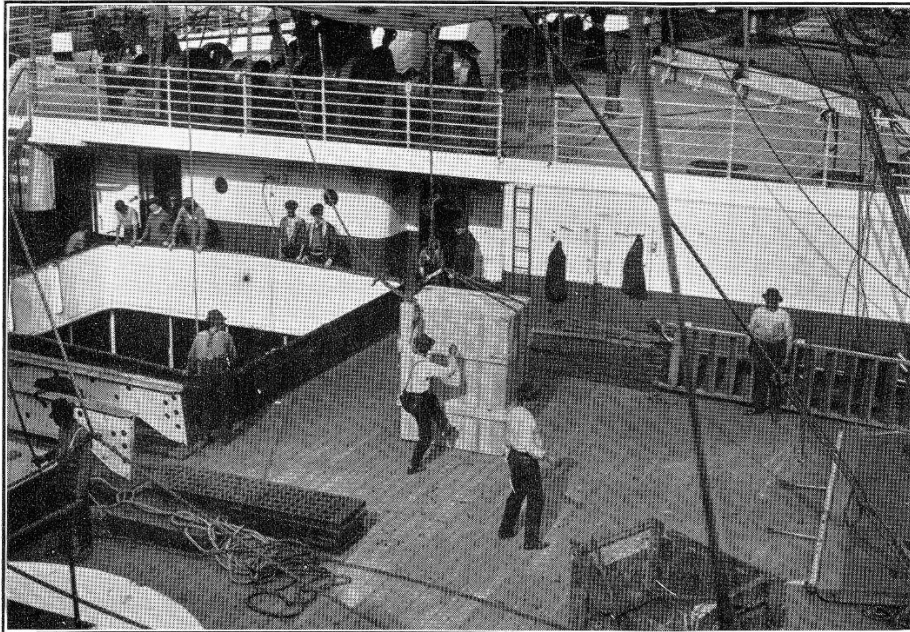
Figure 4

The problem that this presents is that is that if the exterior of the cargo hatch coamings were, in fact, black then it would be almost impossible to distinguish them from the dark mast dados near them. Fortunately, I recently discovered improved quality photos taken of Olympic's forward well deck during cargo operations. The photos were taken from a book called "The Longshoremen". They were taken in bright sunlight which improved the quality of the photos. Because of some structural changes made to Olympic's original configuration, I would date this photo as most likely being post-Titanic disaster sometime in the middle of 1912. Figures 4 and 5 show two of the pertinent photos. It is clear in these photos that the shade of the hatch coaming of cargo hatch #2 is darker than the dark mast painted forward well deck dados.

A large draft has been landed on deck. The gangway man is unhooking the up and down fall. As no regular place is provided for the men's coats, they are seen hanging and lying about

Olympic's forward well deck

One difference with the Britannic Specification Book is that the interior of the hatch coaming is white rather than dark mast. Probably when Olympic's hatch coamings were raised during her 1913 refit, the interiors were repainted dark mast but I don't have any photo evidence of this. However, this does not change the photo evidence that the exteriors of the hatch coamings were visibly darker than the dark mast dadoses and were most likely black. It is also clear in the photos that the interior was painted white at the time of Titanic in 1912.
